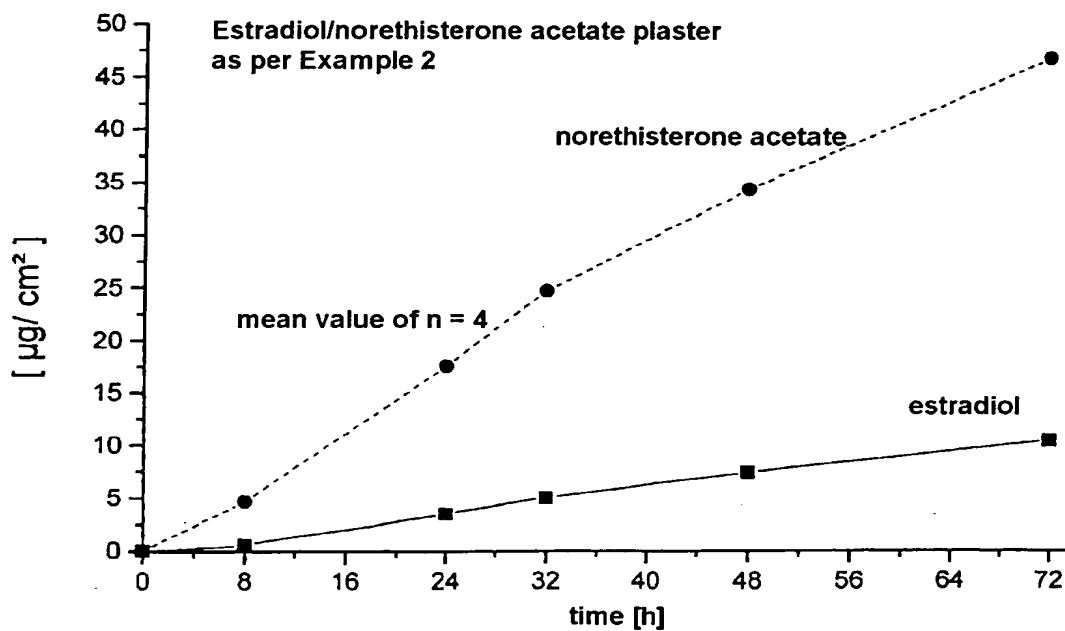
Fig. 3: Results of the permeation study of an estradiol/norethisterone acetate plaster as per Example 2

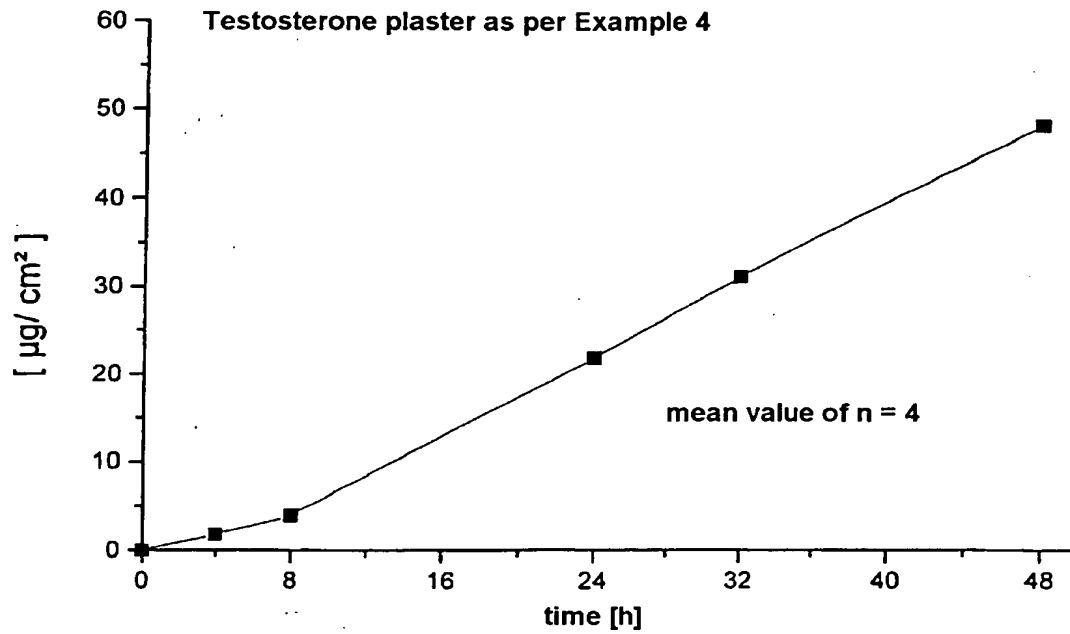
Fig. 4: Results of the permeation study of a testosterone plaster as per Example 4
